Manhole Inspection Summary

Manhole # S41A2_003MH

Insp Date: **12/7/07 8:04 AM**

Location Address: **3804 9th St**

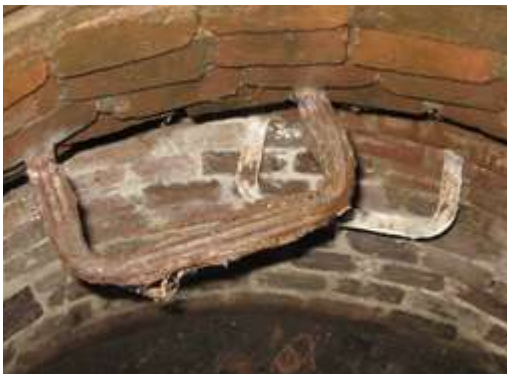
Steps

Count: **2** Missing: **0** ☐ Corroded

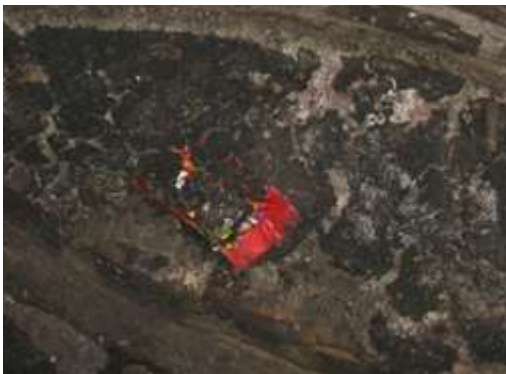
Defect 1

Debris

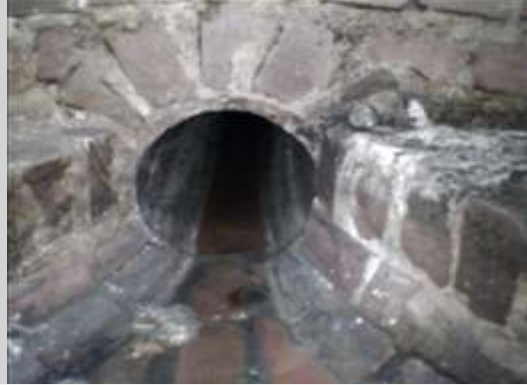
12 O'Clock Outflow

8 in. Circular Gravity Sewer
Pipe Out @ 12 O'Clock

Pipe Height: **9.6** (in.) Rod and Bar (Angled)
Pipe Material: **Clay** ☐ Pipe Lined
Invert Depth: **5.68** (ft.) Flow Characteristics: **Fast**
Deposits: ☒ None ☐ Mud ☐ Sludge ☐ Debris ☐ Grease
Silt Depth: (in.) Deposits Extent:
Infiltration: **None** Pipe Seal Cond: **Sound**

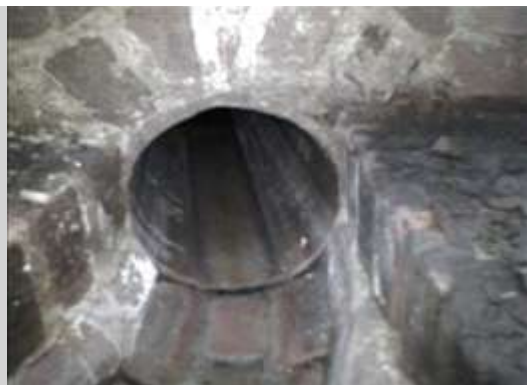
3 O'Clock Inflow

8 in. Circular Gravity Sewer
Pipe In @ 3 O'Clock

Pipe Height: **10.8** (in.) Rod and Bar (Angled)
Pipe Material: **Clay** ☐ Pipe Lined
Invert Depth: **5.60** (ft.) Flow Characteristics: **Fast**
Deposits: ☒ None ☐ Mud ☐ Sludge ☐ Debris ☐ Grease
Silt Depth: (in.) Deposits Extent:
Infiltration: **None** Pipe Seal Cond: **Sound**

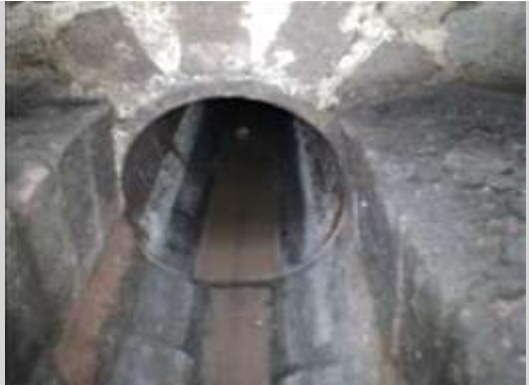
6 O'Clock Inflow

8 in. Circular Gravity Sewer

Pipe In @ 6 O'Clock

Pipe Height: **9.6** (in.) Rod and Bar (Angled)

Invert Depth: **5.60** (ft.) Flow Characteristics: **Slow**

Deposits: ☒ None ☐ **Mud** ☐ Sludge ☐ Debris ☐ Grease

Infiltration: **None** Pipe Seal Cond: **Sound**

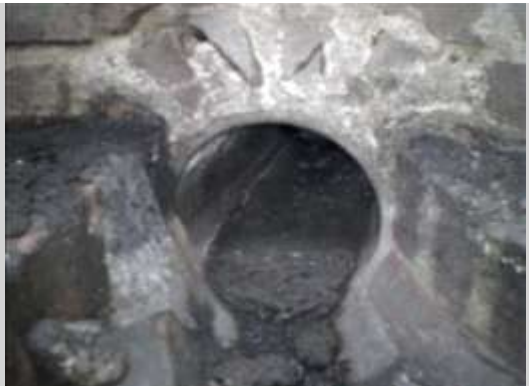
9 O'Clock Inflow

6 in. Circular Service Sewer

Pipe In @ 9 O'Clock

Pipe Height: **8.4** (in.) Rod and Bar (Angled)

Invert Depth: **5.40** (ft.) Flow Characteristics: **None**

Deposits: ☐ None ☒ **Mud** ☐ Sludge ☐ Debris ☐ Grease

Silt Depth: **3** (in.) Deposits Extent: **Medium**

Infiltration: **None**

Pipe Seal Cond: **Sound**
